Overview

1216 South Kappes Street Indianapolis, IN 46221

Proposed Improvements / Option A

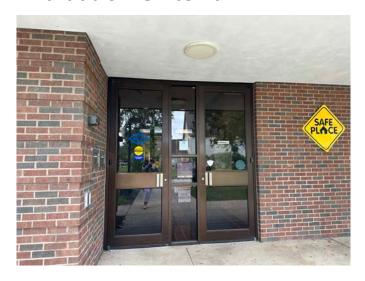
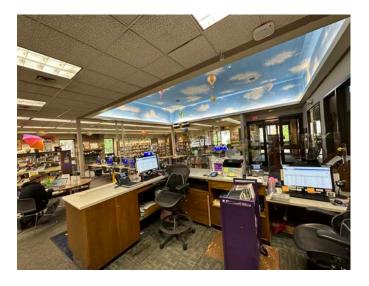
• The entry is dark and uninviting. However, once inside the library space, it is easy to see staff and understand the full layout of the space.

- It appears that although this building is well located, it is in need of functional reconfiguration and updates to better serve the needs of this community. Expansion should be considered if possible on the site.
- Many patrons walk to this branch or rely on public transportation.
- There is a need for restrooms to be larger, reconfigured, and with reliable plumbing. Some unhoused patrons use the restrooms here to clean up as needed.

• The interior is in poor condition. This building is in need of a complete renovation and reconfiguration that will update all flooring, finishes, furniture, millwork, the service desk, lighting, etc.

- The restrooms are not accessible
- The doors to enter the building are in need of repair
- Shelving aisles may be tight for patrons with assistive devices and difficult to move around at the far ends of the stacks. Additionally, materials are located both at the top and bottom of the shelves.

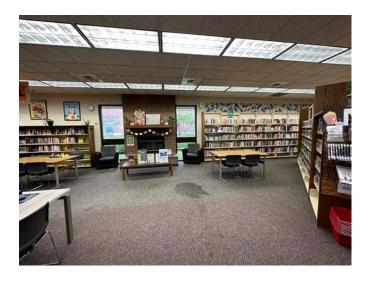
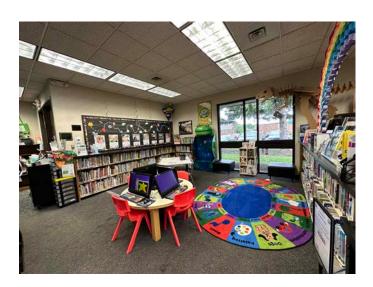
• The library's parking lot is small but adjacent parking is available for shared use through partnership with the Mary Rigg Neighborhood Center.

- The Holds are located behind the service desk.
- There is a self-checkout station located on the service desk.

• There is an exterior walk-up book drop next to the building entry. This feeds into a secure room accessed from the vestibule.

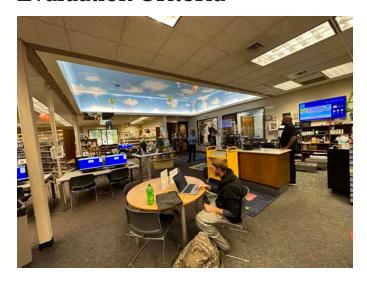
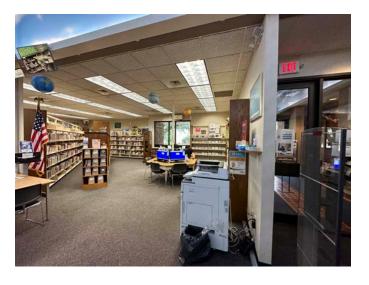
- Materials are primarily processed through the staff workroom.
- The staff office and workroom are tight and double as the staff lounge.
- This branch does not have an automated materials handling system.

- This branch is operated with a single combined service desk.
- The desk is well located with direct views to the entry, corridor leading to the restrooms, community room doors, public computers, and is adjacent to the children's area.
- The desk is well sized for the space and large enough for staff to work on projects while at the desk.
- However, the desk is dated, worn, and should be replaced as part of a comprehensive renovation project.

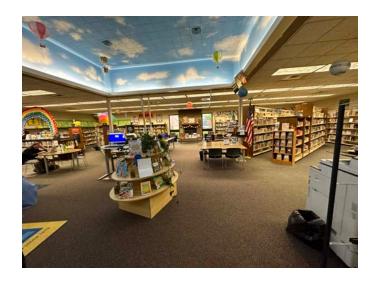
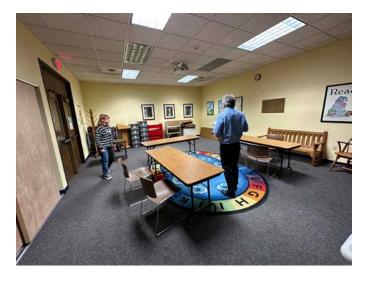
• Collections are housed on taller shelves due to lack of space. Shelves are full with some overflowing in the children's area.

- The perimeter shelving is easy to navigate.
- Stand alone shelving is tall and in long runs due to lack of space.

The children's area is tight and lacks space for interactive or imaginative play elements.

The community room is accessed from the vestibule and a small hallway near the restrooms. There is no visibility into this room from the library and also no windows to the outside.

• There is a combination of lounge and table seating primarily located in front of the fireplace.

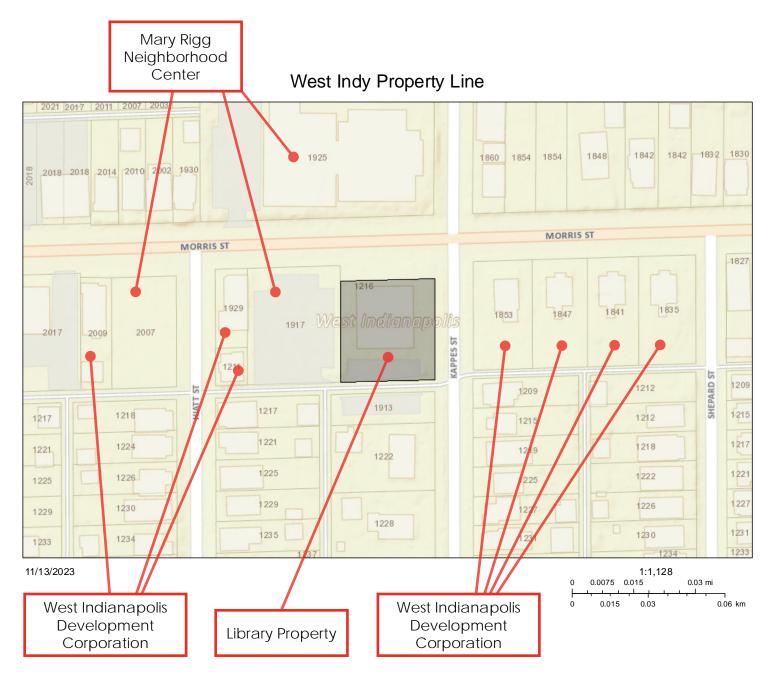
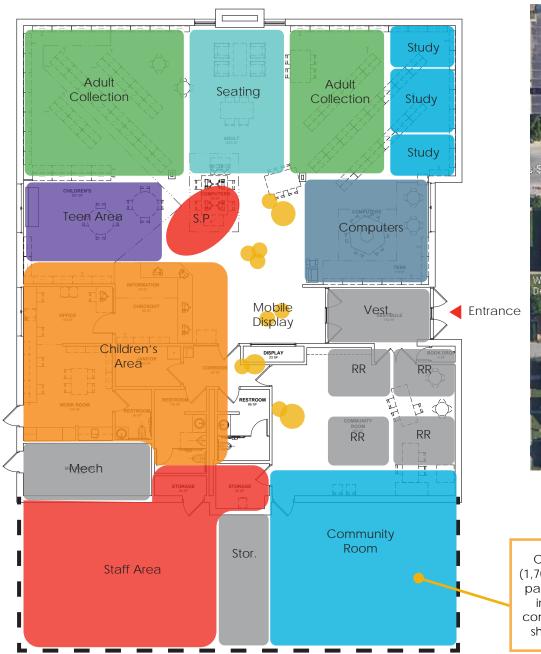
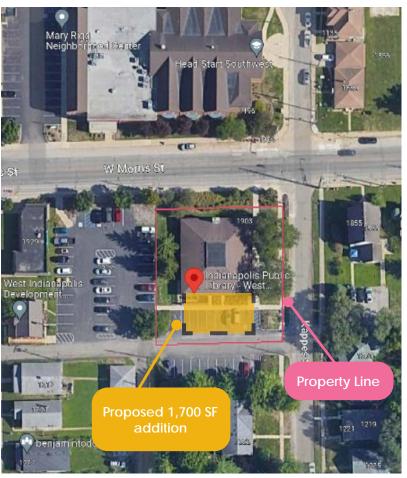
Proposed Improvements / Option B

Consider an addition (1,700 SF) over the existing parking lot and entering into partnership with community neighbors for shared parking lot use
